Investigation of Fire September 1988 Lease OCS-G 1633 Main Pass Block 133

**Gulf of Mexico Off the Louisiana Coast**

by Rufus P. Kirk Felix G. Dyhrkopp Robert C. Lanza William D. Terrebonne, Sr.

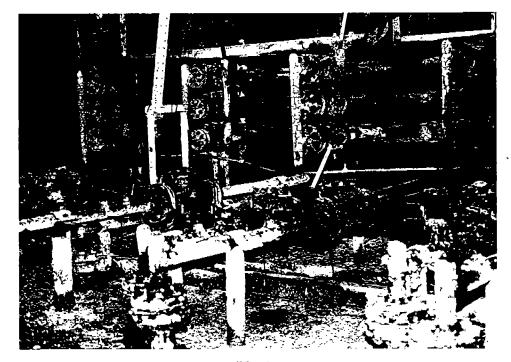
Header

The most severe damage was in the pipeline pump room and header room (see attachments 6 and 7). The pipeline pump and header were severely damaged, and the generator skid electrical control panel was completely destroyed (see attachment 7). There was moderate damage in the Southern Natural Gas pipeline room. There was extensive damage to the 8-foot transverse and longitudinal plate girders of the structure in the vicinity of Door A (see attachment 8). The firewalls and decking were buckled moderately. The meter buildings and radio room were destroyed.

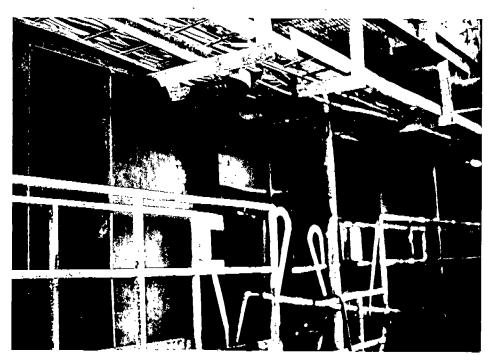
Plate Girder --- Buckled Above Door A

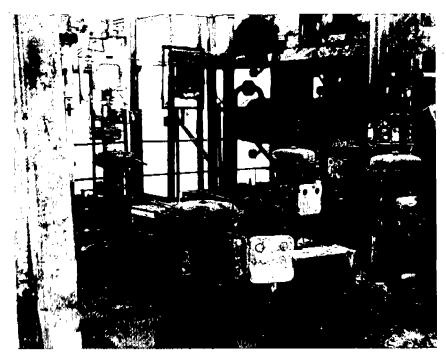
Production Equipment Area

The upper deck was most severely damaged in the areas of the production equipment, compressor, and glycol unit (see attachment 9). The tool shed was destroyed. It is estimated that the total damage was approximately \$5 1/2 million.
